Date: January 12, 2024

Subject: Structural Status of Foundation of Property Located at
209 Orchard Road
Romney, WV 26757

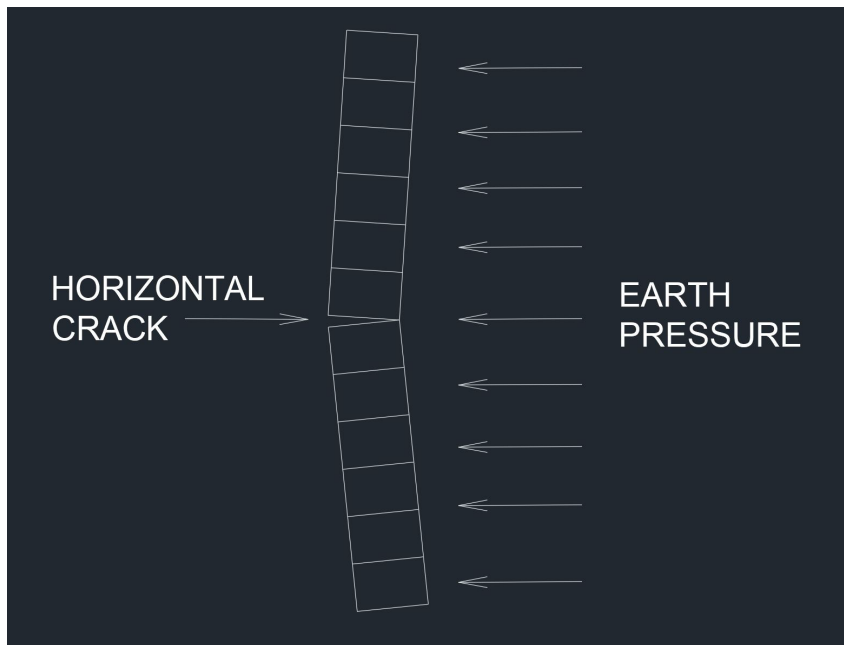
This diagram illustrates what is happening. The pressure outside pushes the wall inward, and as it bows, the CMU blocks pull apart like shown.

What is seen inside is the horizontal crack. That is what is happening here.

This is caused by improper surface drainage.

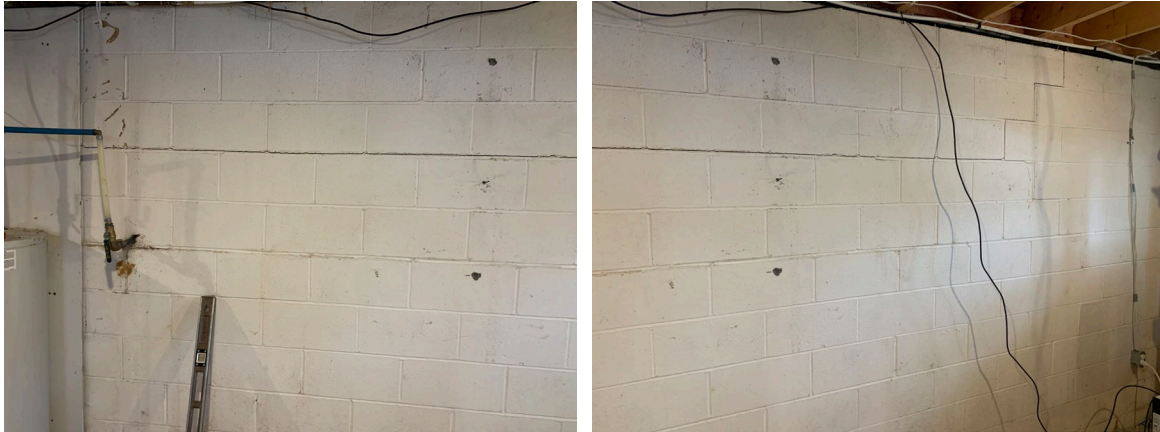
These two pictures show about half of the left side of the room and most of the right. You can see that the horizontal crack extends nearly across the entire wall. There is a stair step crack on the right side. That type of crack is indicative of differential settlement.

Differential Settlement is where one part of a wall settles more than another, and so something has to give. With a CMU block wall, it is typically the mortar joints that crack. However, they can also split the block.

In this case, it appears that the corner of the structure is laying wetter than the center, and so the corner has settled more than the center.

1. Correct the surface drainage in the upper yard.
2. Make sure water is not pooling at the lower corner where the differential settlement cracking is occurring. Some minor grading may be required down there as well.
3. Have a mason repoint all of the cracks in the basement.
4. Buttress the wall with steel I-Beams and angles

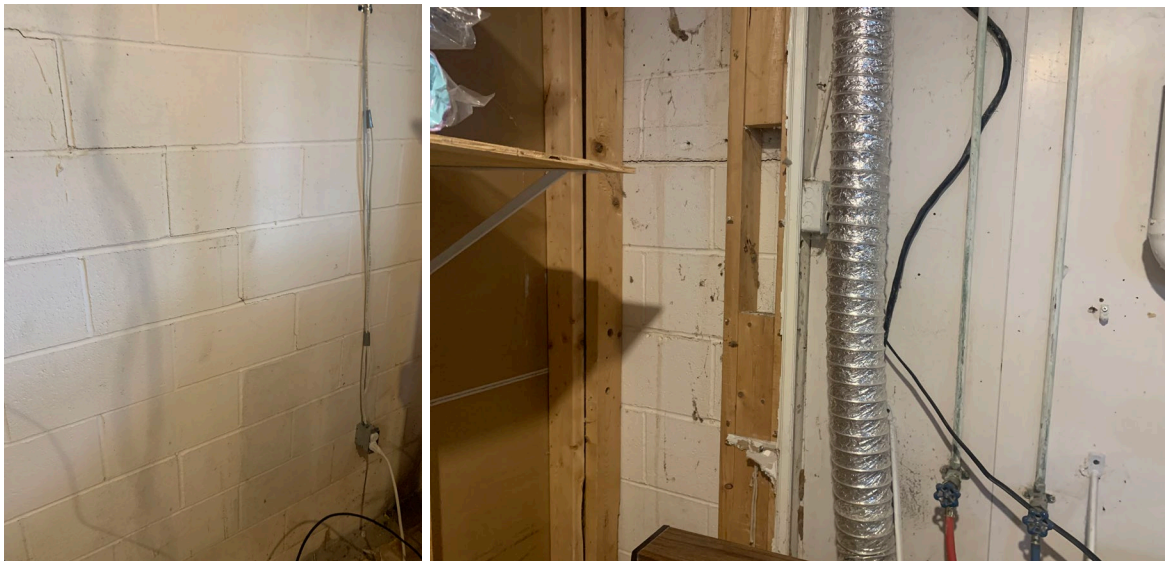
The left picture is a closeup of the stair step differential settlement crack. The right picture shows the horizontal crack extending clear over to the wall.

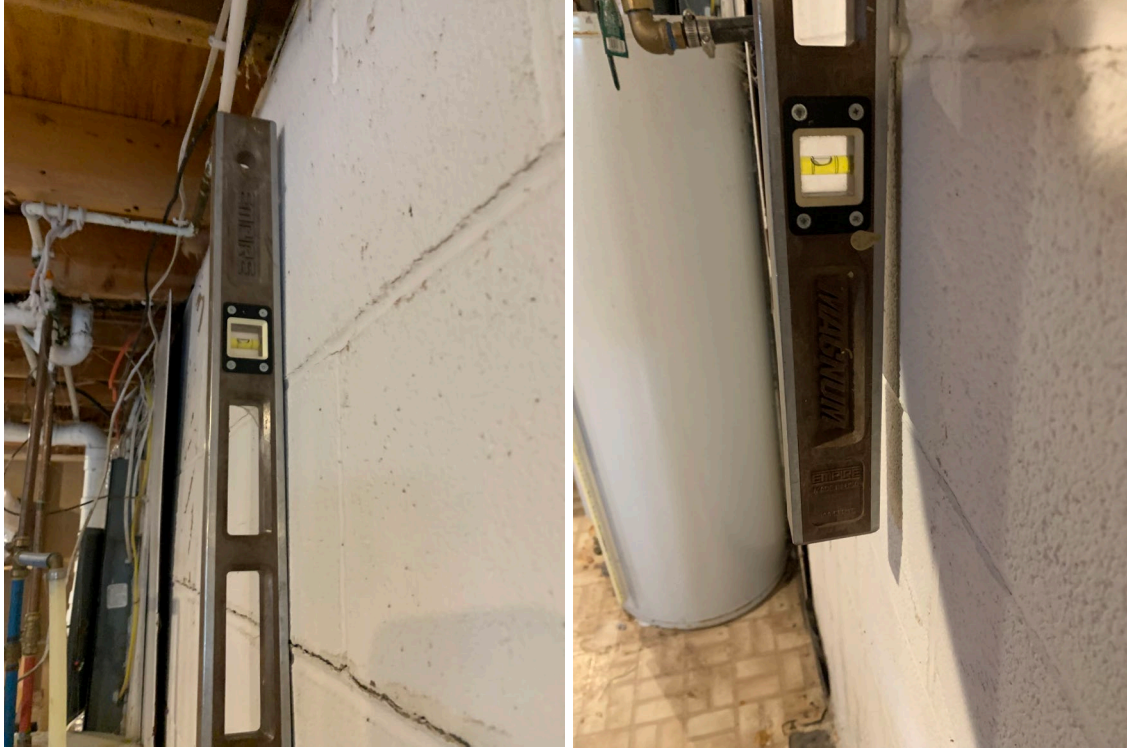
These two pictures show the extent of the horizontal bowing. It's about a half inch. While this is not optimum, I have seen much worse.

However, in this case, the bowing is not so severe as to require this, especially in light of how difficult it would be to do.

In this case, I recommend buttressing the wall inside. I would Kwik-Bolt a 2x2x1/4" steel angle to the floor, and lag bolt one to each floor joist above. These would hold 4" steel I-Beams vertically against the wall. Put a vertical I-Beam every 16" down the length of the wall. Bolt each I-Beam to both of the channels to stabilize them.

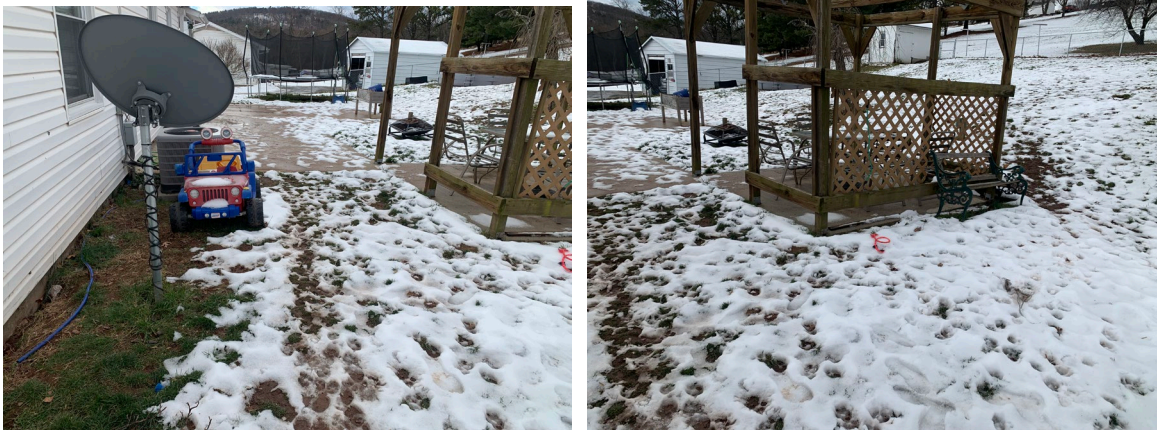
This is the back yard just above the section of wall in the photos above. The backfill has settled, and the whole yard is on a slope. Surface water has been running down hill against the house, saturating the ground by the wall, and causing it to swell and create hydraulic pressure. This is what is causing the large horizontal crack.

An extra amount runs down and around and lays against the corner, and that is what is causing the differential settlement cracking.

To prevent this from happening again or getting worse, the yard needs to be regraded and some drainage swales added. Using dirt fill, build up against the house so that the dirt is a good 6" or so higher against the house and the yard. Taper it down to yard level about 6-8' out from the house. Then, cut a swale from the edge of the patio arcing out toward the hill and down toward the driveway. Do the same thing on the other side of the patio, arcing out around that side of the house and down hill.

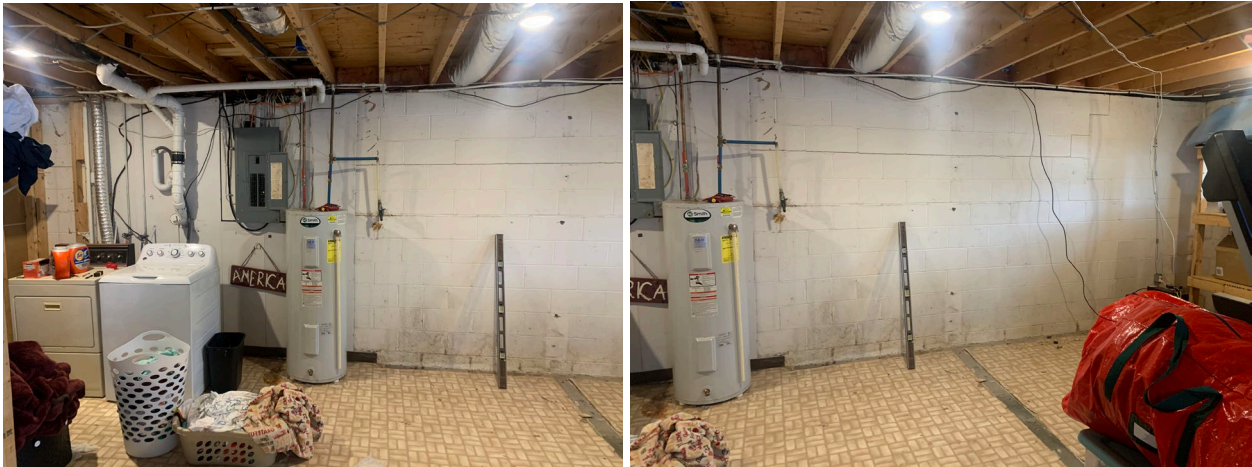
These two pictures are a zoom out showing the entire room (I couldn't get it all in one shot). But the cracking can be seen to line up with the outside pictures.

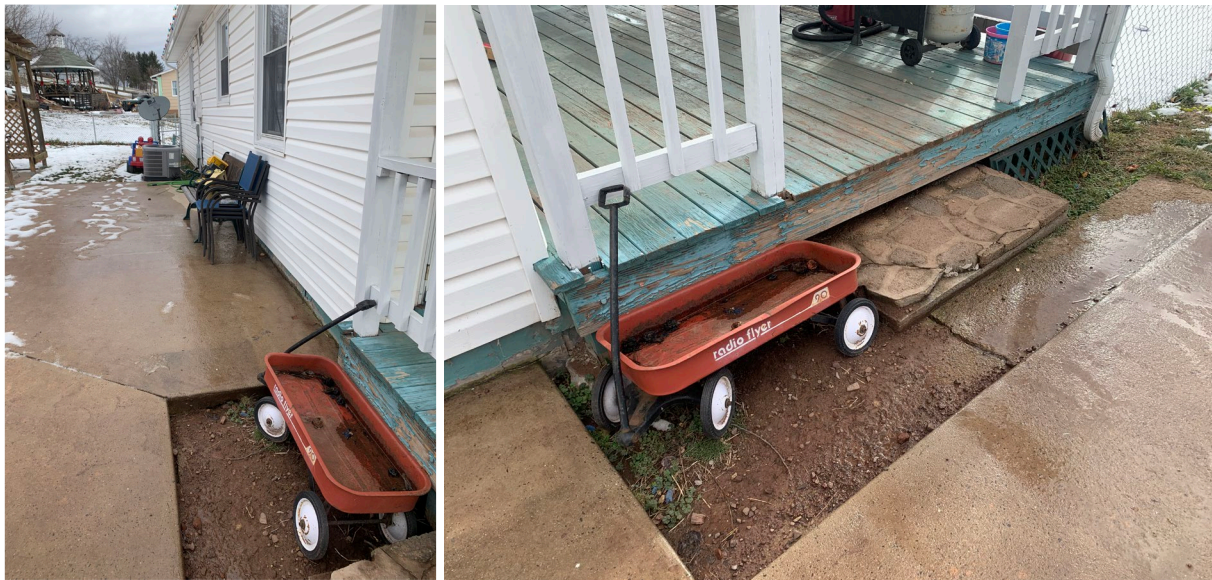
These two pictures show the opposite end of the house, by the portion of the basement that is finished and the wall is not visible. It can be seen that the patio has settled and has pitched toward the house. And, the little dirt depression by the wagon is also allowing water to run toward the house.

The patio itself might need a topper slab poured on top of it to get rain water to run away from the house. It has settled and is running water against the house. If this is not practical right now due to weather, then I'd recommend some type of industrial silicone caulk or something along the crack where the patio meets the foundation wall. This needs to be sealed up.

The best repairs would be to either hammer it out altogether and just build it up with soil and replant grass, hammer it out and pour a new slab that is pitched the correct way away from the house, or pour a new slab on top of the existing slab. If a new slab is poured, do not go thinner than 2.5" on the thin end and get it high enough on the house end to have a good positive drainage. Probably something like 6-8" thick against the house and 3" thick away from the house. Put welded wire fabric in it for crack control. It would be difficult, however, due to location, to get a concrete truck in there. But, something needs to be done to stop the water running across the patio and down the crack against the foundation.

A simpler repair that would help would be to pour a concrete "wedge" against the house on the patio. Something like a wedge that would come up about 6", to just under the siding, and then taper out to about 1.5" thick say a foot out from the house. That would be easy to do, inexpensive, and at least stop the water from going behind the slab.
