WILLIAMS INSPECTION SERVICES RESIDENTIAL REPORT

6684 Carpers Pike
Yellow Spring, WV 26865

MARCH 27, 2023

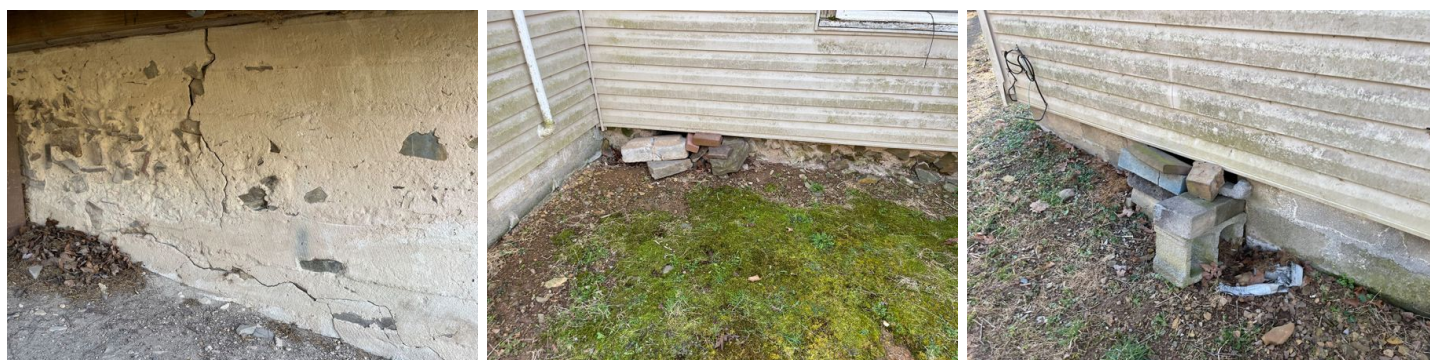
3.1.1 Foundation, Basement & Crawlspaces

OBSERVATIONS

The crawlspace accesses are undersized by modern standards and large portions of the foundation were not visible for inspection due to lack of access at the exterior and lack of clearance at the crawlspace. Recommend a licensed foundation repair contractor and/or structural engineer evaluate the structure and develop a plan for repair. Additionally, there is a large crack at the foundation below the laundry area.

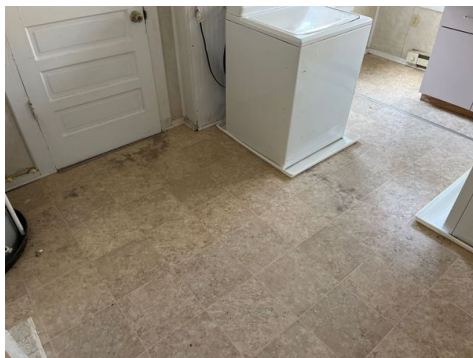
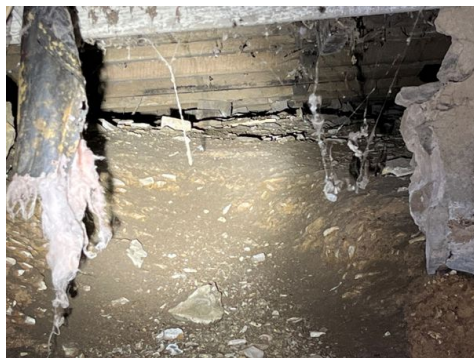
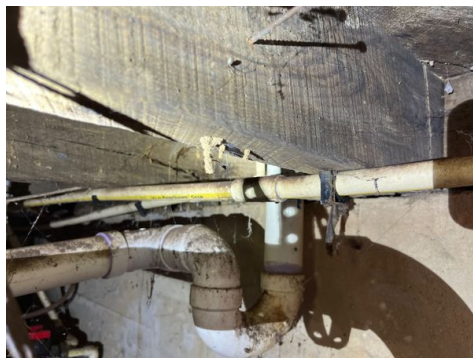
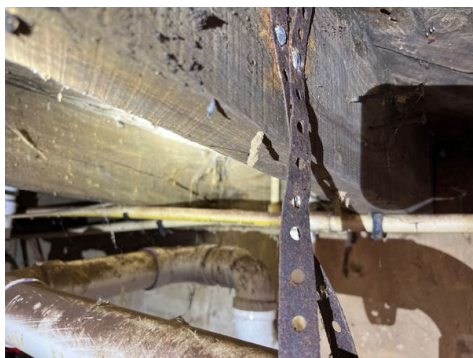
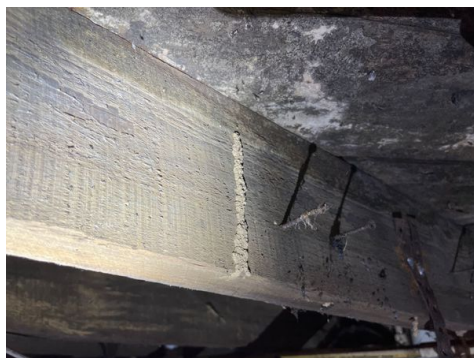
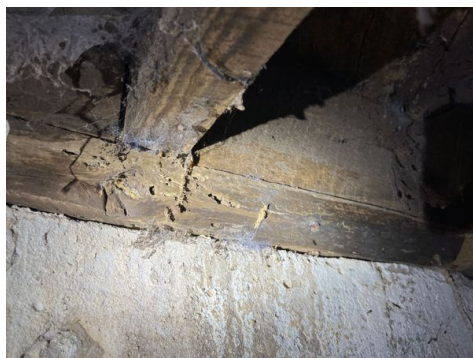
3.2.1 Floor Structure

FLOOR STRUCTURE OBSERVATIONS

Large areas of the floor structure below the main living areas of the home were inaccessible due to lack of adequate clearance from the floor structure to grade below the home. The extent of any damaged and condition of the structure is unknown. Below the laundry room, there is evidence of significant deterioration and lack of support throughout the floor structure and subfloor. A large majority of the deterioration appears to be due to previous wood destroying insect activity. In many areas above this location the floor is unstable/soft and a potential safety hazard. It is recommended that a licensed structural engineer evaluate the floor structure of the entirety of the home and that a plan of repair be developed and completed. The extent of damage hidden behind wall coverings is unknown.

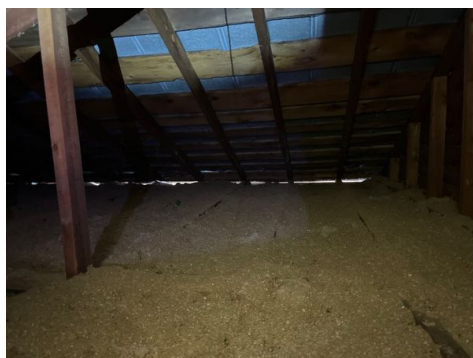
3.5.1 Roof Structure & Attic

VISIBLE LIGHT TO THE EXTERIOR

At the attic, there is visible light to the exterior. Recommend properly sealing the attic from the exterior to avoid pest or moisture intrusion.

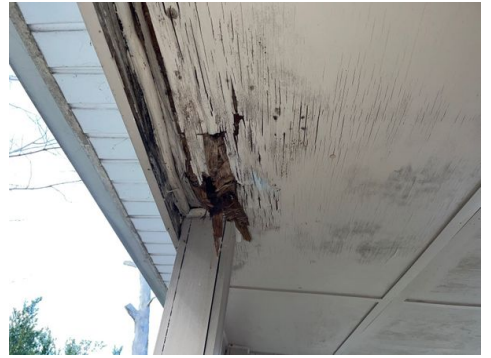
3.5.2 Roof Structure & Attic

FRONT PORCH DAMAGE

The front porch ceiling is deteriorated near an area that looks to be damaged by previous water intrusion likely from full gutters/openings in the metal roof. Recommend a qualified contractor repair.

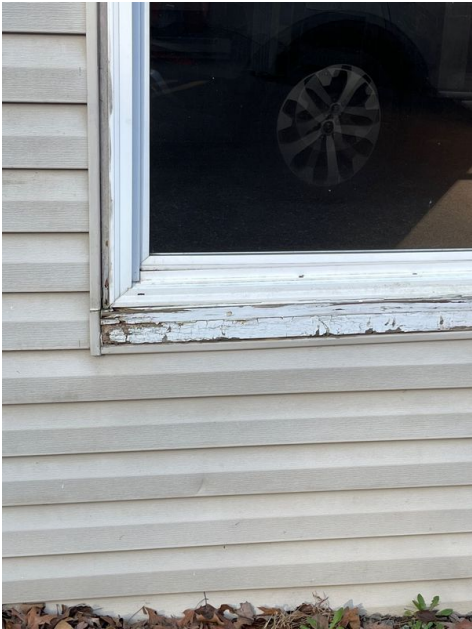
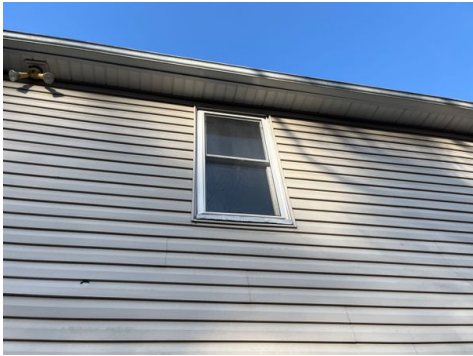
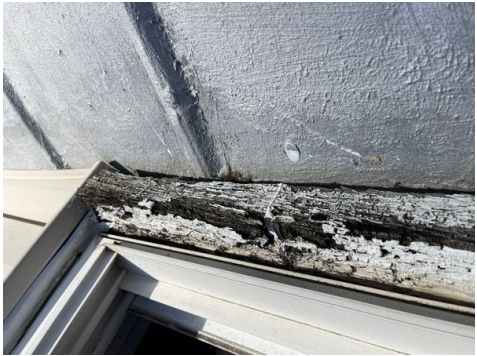
The exterior windows do not appear to be properly flashed and the window sills/trim are deteriorated. Recommend repair by a qualified contractor.

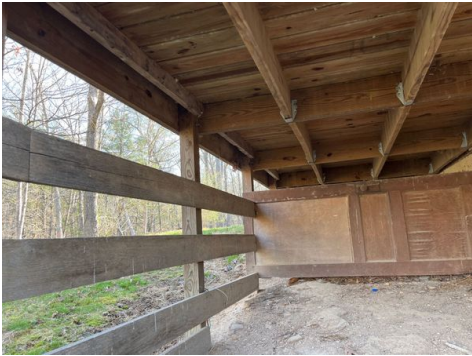
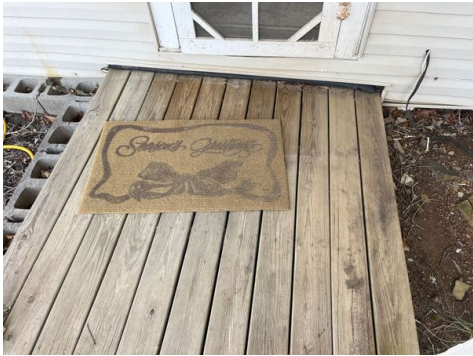
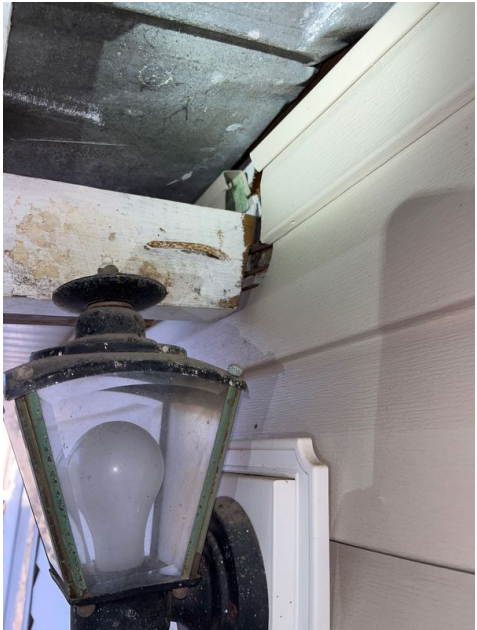
5.4.1 Decks, Balconies, Porches & Steps

OBSERVATIONS

The rear covered deck area support structure is not secured to modern standards, the front side porch deck is sloped toward the structure and unstable and the side front porch roof is separated from the structure. Recommend repairs be made by a licensed contractor.

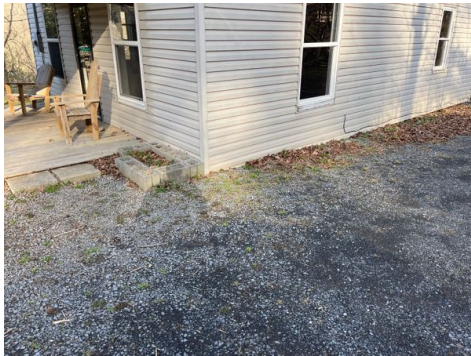
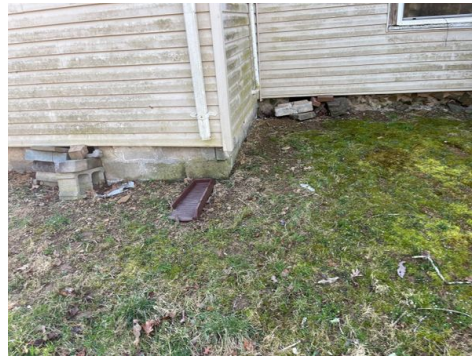
5.6.1 Vegetation, Grading, Drainage & Retaining Walls

The grading is sloping towards the home and/or is level in some areas. This could lead to water intrusion at the exterior foundation walls and unwanted settling. Recommend consulting with a landscape contractor and maintaining at least 6 inches of grade slope away from the foundation for the first 10 feet (roughly 5% slope). If proper sloping cannot be achieved in some instances a swale may be installed.

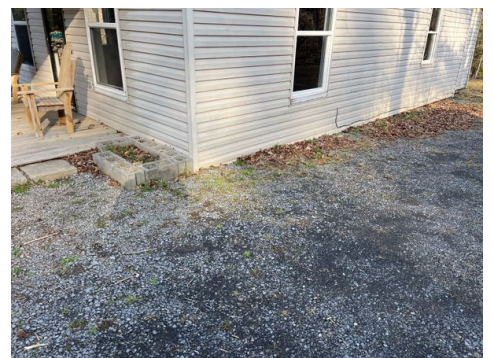
5.6.2 Vegetation, Grading, Drainage & Retaining Walls

HIGH GRADE

At the exterior, there are areas where the grade is higher than recommended. Recommend maintaining at least 4 inches of clearance from the grade to masonry style sidings and trim and 6 inches to wood, vinyl and composite sidings and trim. This is a conducive condition for Wood Destroying Insect (WDI) activity and potential moisture intrusion. The extent of any WDI activity or water damage at the wall/floor cavities is unknown. In some instances re-grading may be necessary.

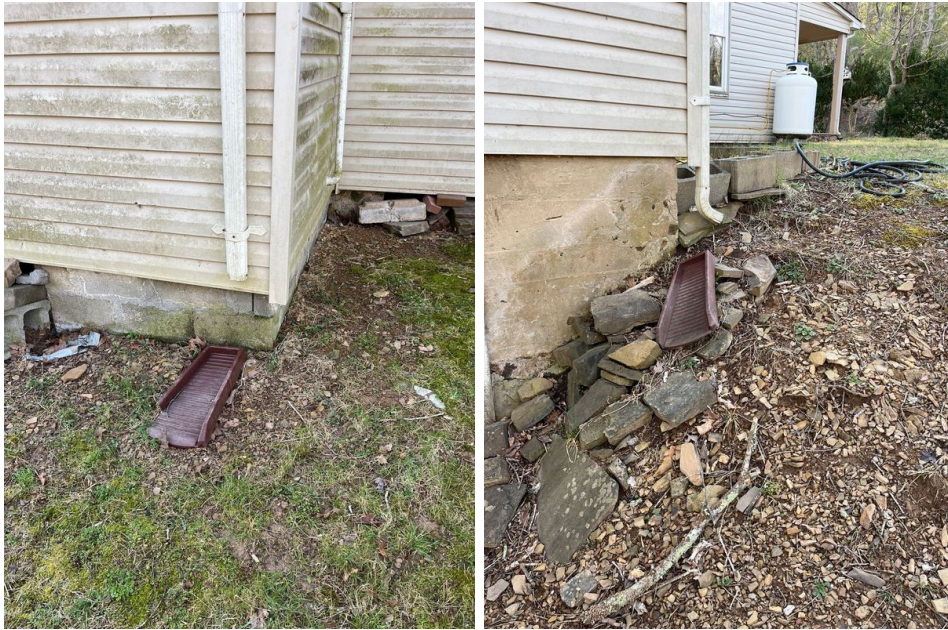
5.6.3 Vegetation, Grading, Drainage & Retaining Walls

DOWNSPOUT DRAIN AT FOUNDATION

One or more downspouts drain too close to the home's foundation or their extensions are damaged and possibly allowing spillage near the foundation or porch. This can result in excessive moisture in the soil at the foundation, which can lead to foundation/structural movement and/or moisture intrusion at foundation walls. Recommend adjusting downspout extensions to drain at least 6 ft. away from the foundation.

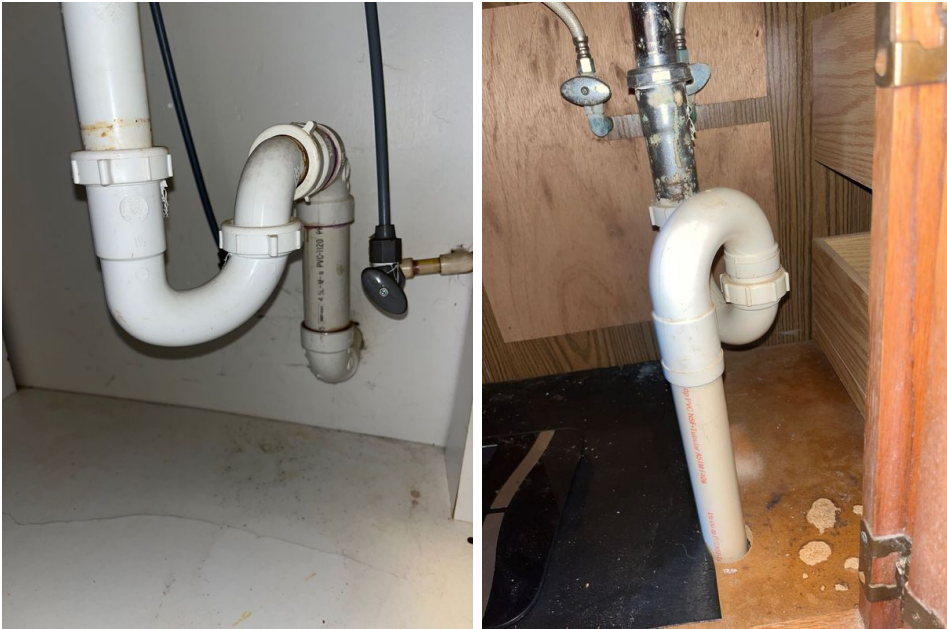
There is an S-Trap configuration at the sink drain line. It is recommended that a proper P-Trap be installed to avoid potential for plumbing gases to backup from the sink drain and to allow for proper venting of the drain.

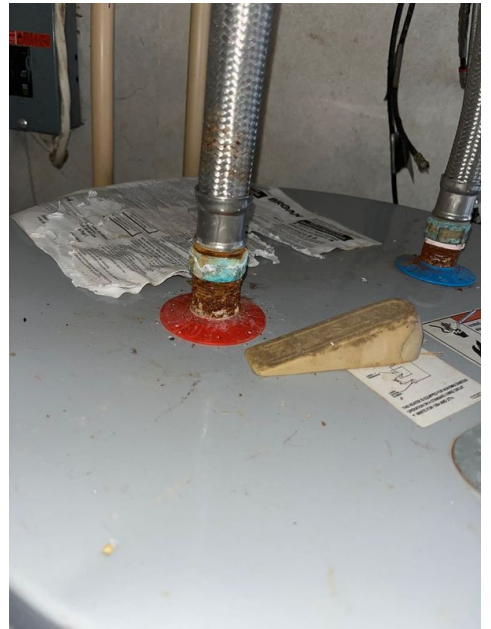
6.3.1 Water Heater

EVIDENCE OF PREVIOUS LEAKING

There is evidence of previous leaking at the water heater/connections. Recommend monitoring these locations for future leaking and repairs be made as necessary.

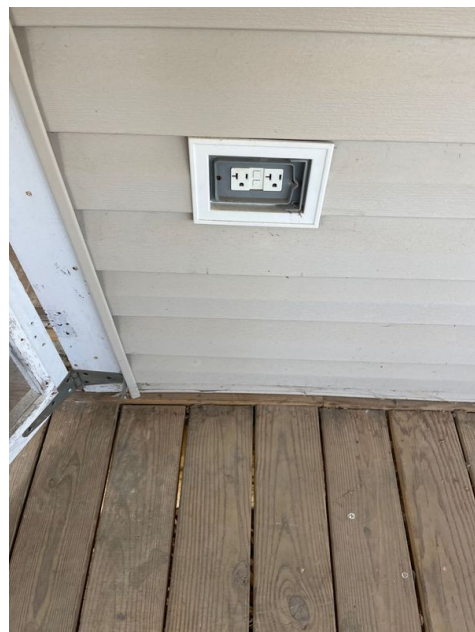
DAMAGED RECEPTACLE(S)

There is a damaged electrical receptacle(s). Recommend replacement by a licensed electrician.

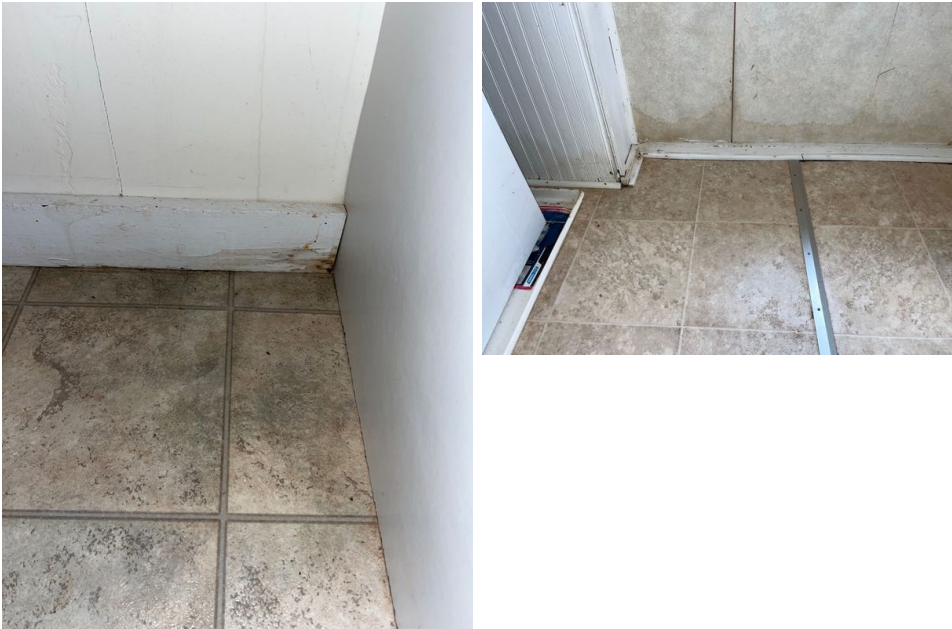
EVIDENCE OF PREVIOUS WATER DAMAGE

There is evidence of previous water staining/damage at the wall. The extent of any water damage at the wall cavity is unknown. Recommend consulting with the seller about the damage.

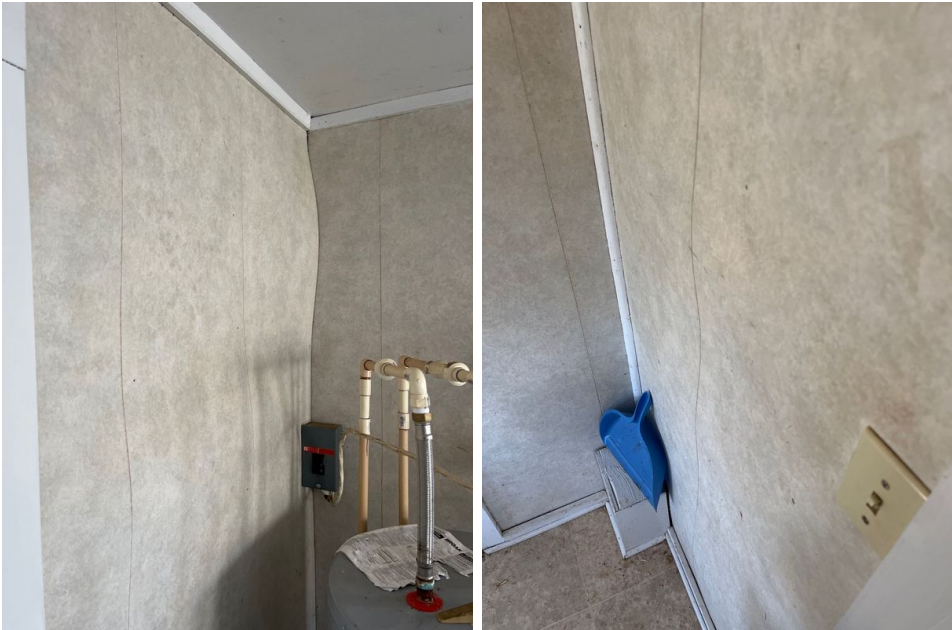
10.1.2 Walls

PANELING OBSERVATIONS

The wall paneling is buckled/damaged. This can be a sign of previous water damage and/or improper installation. Recommend evaluation and repair. The extent of damage behind walls and paneling is unknown.

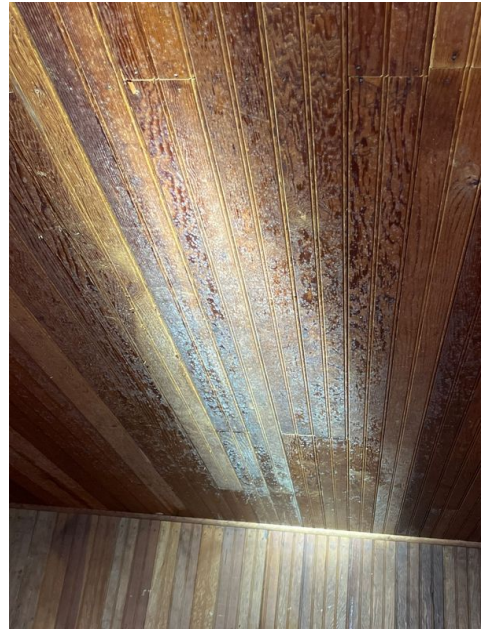
10.2.1 Ceilings

DISCOLORATION/GROWTH
THROUGHOUT HOME

Discoloration and/or water staining is present at the ceiling. We did not test or determine if this growth is or is not a health hazard. The underlying cause is moisture. Recommend contacting a mold inspector or qualified expert for investigation and correction as necessary. The extent of any damage at the ceiling cavities is unknown.

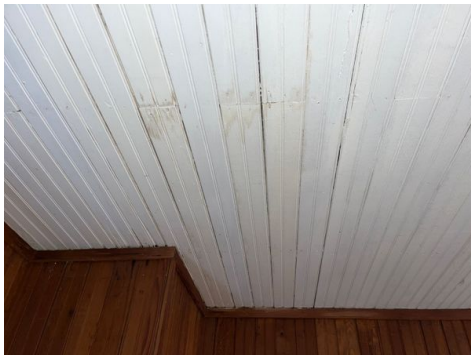
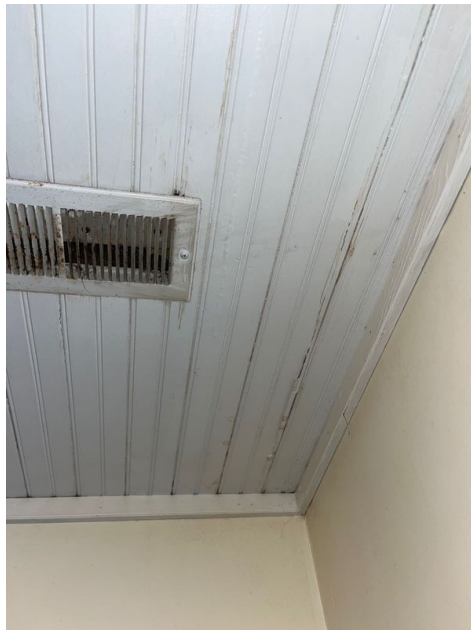
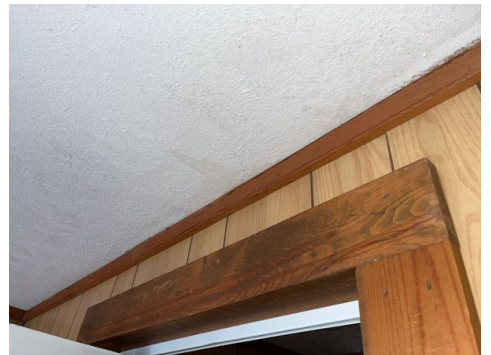
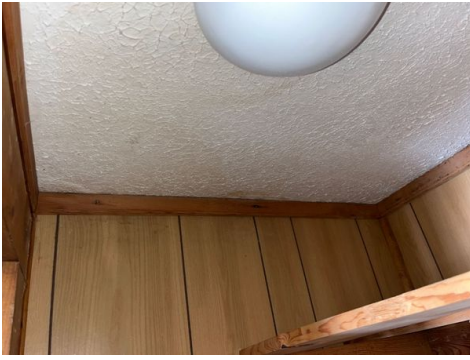
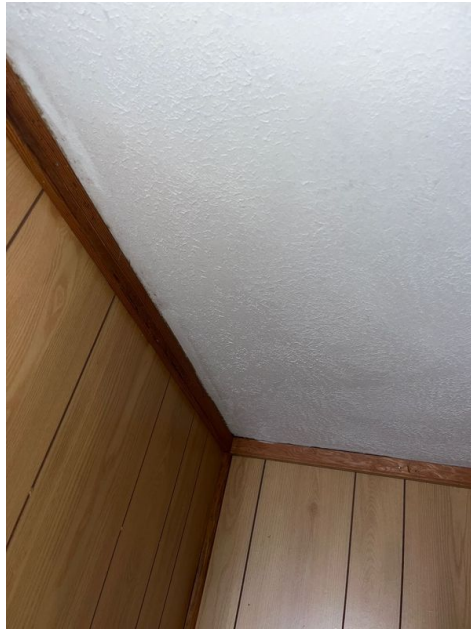
10.2.2 Ceilings

EVIDENCE OF WATER DAMAGE

MAIN LIVING ROOM, KITCHEN, UPSTAIRS BELOW CHIMNEY AREA

There is evidence of water damage at the ceiling covering. The extent of any water damage at the ceiling cavity is unknown. Recommend evaluation and repairs be made by a licensed contractor. Recommend consulting with the seller about this damage.

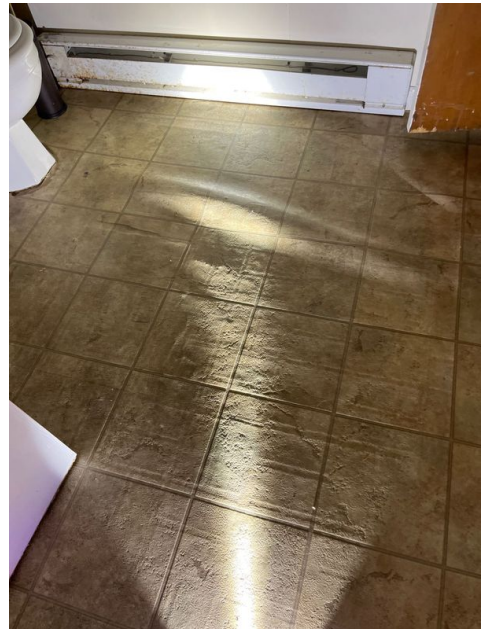
10.3.1 Floors

DAMAGED (GENERAL)

The flooring was damaged in multiple areas throughout the structure.

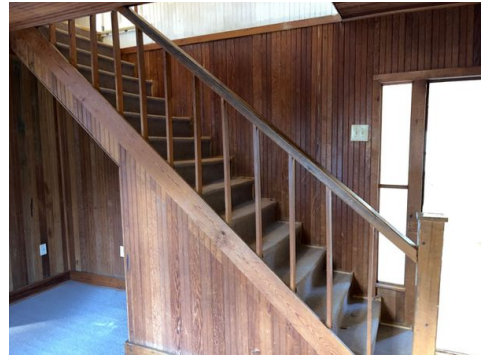
The baluster/handrail spacing is not up to modern safety standards. The space between balusters should not allow passage of a 4 3/8-inch sphere for child safety. Recommend installation to modern standards.

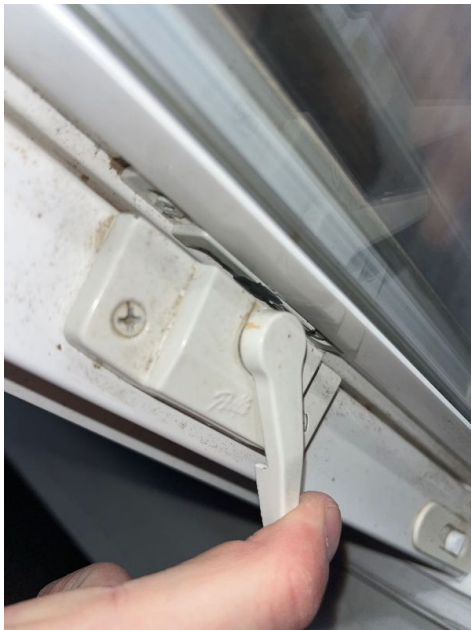
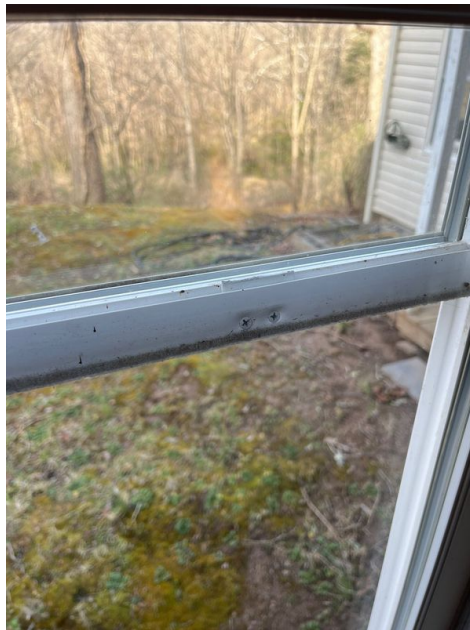
MAIN LIVING ROOM MULTIPLE WINDOWS, UPSTAIRS REAR RIGHT BEDROOM

There is a window latch that does not line up as intended causing the window latch to be inoperable. Recommend repairs be made.

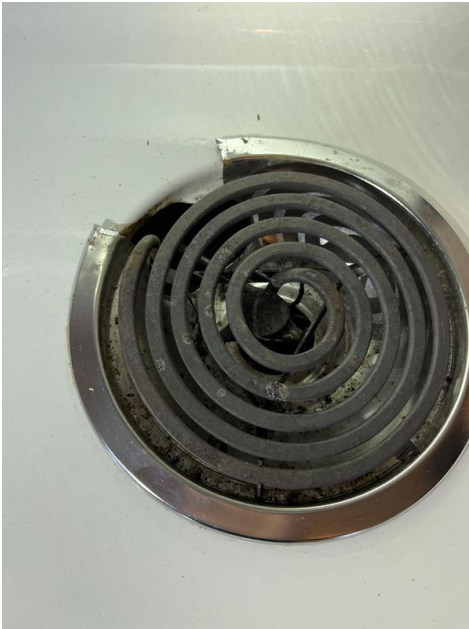
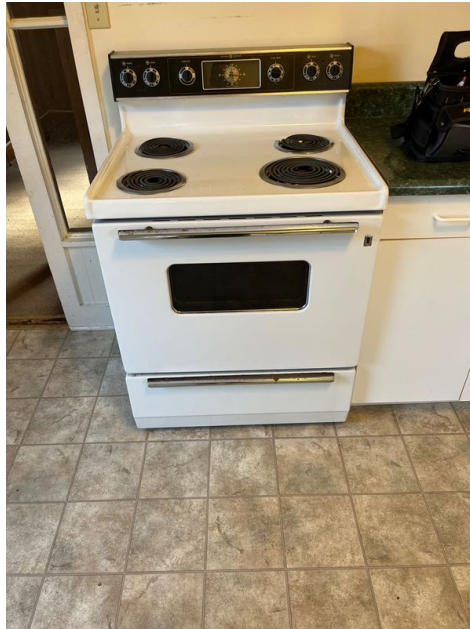
DATED APPLIANCES

The kitchen appliances are dated. Recommend budgeting for future replacement.
