Date: January 12, 2024

Subject: Structural Status of Foundation of Property Located at
209 Orchard Road
Romney, WV 26757

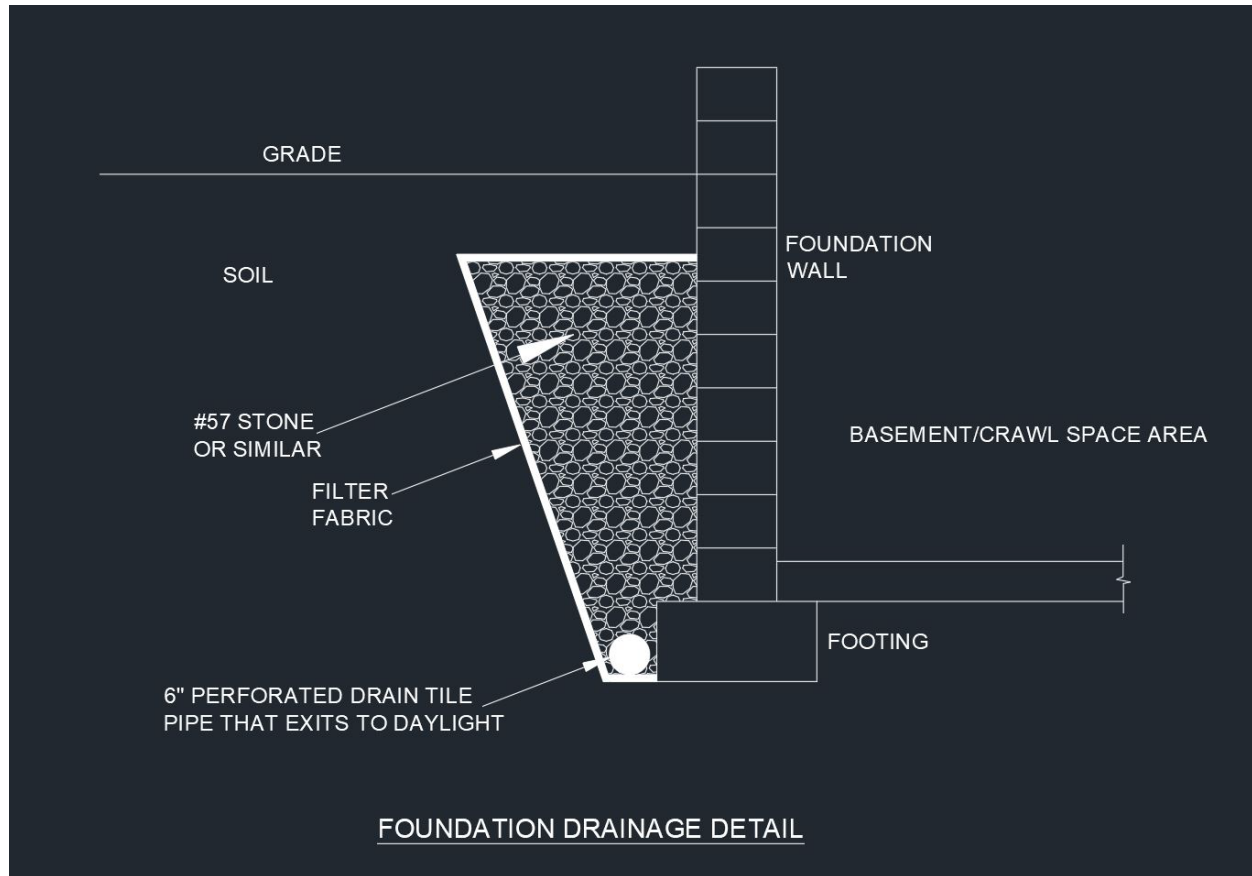
As I'd told Eric, the best way is to get a backhoe and dig up around the house along the entire wall down to the foundation to relieve the pressure. Then, from the inside, push the wall back out and into place. Get a mason to redo the joints. Then, on the outside, using filter fabric and #57 stone, put a French drain along the entire back of the house to get the water out.

However, in this case, the bowing is not so severe as to require this, especially in light of how difficult it would be to do.

In this case, I recommend buttressing the wall inside. I would Kwik-Bolt a 2x2x1/4" steel angle to the floor, and lag bolt one to each floor joist above. These would hold 4" steel I-Beams vertically against the wall. Put a vertical I-Beam every 16" down the length of the wall. Bolt each I-Beam to both of the channels to stabilize them.
